Ballater & Crathie Community Council (BCCC)

December 2015 Ballater Flood

Flood Information Group
December 2015 Ballater Flood
Report 1 Causes, Mechanism & Uncertainties

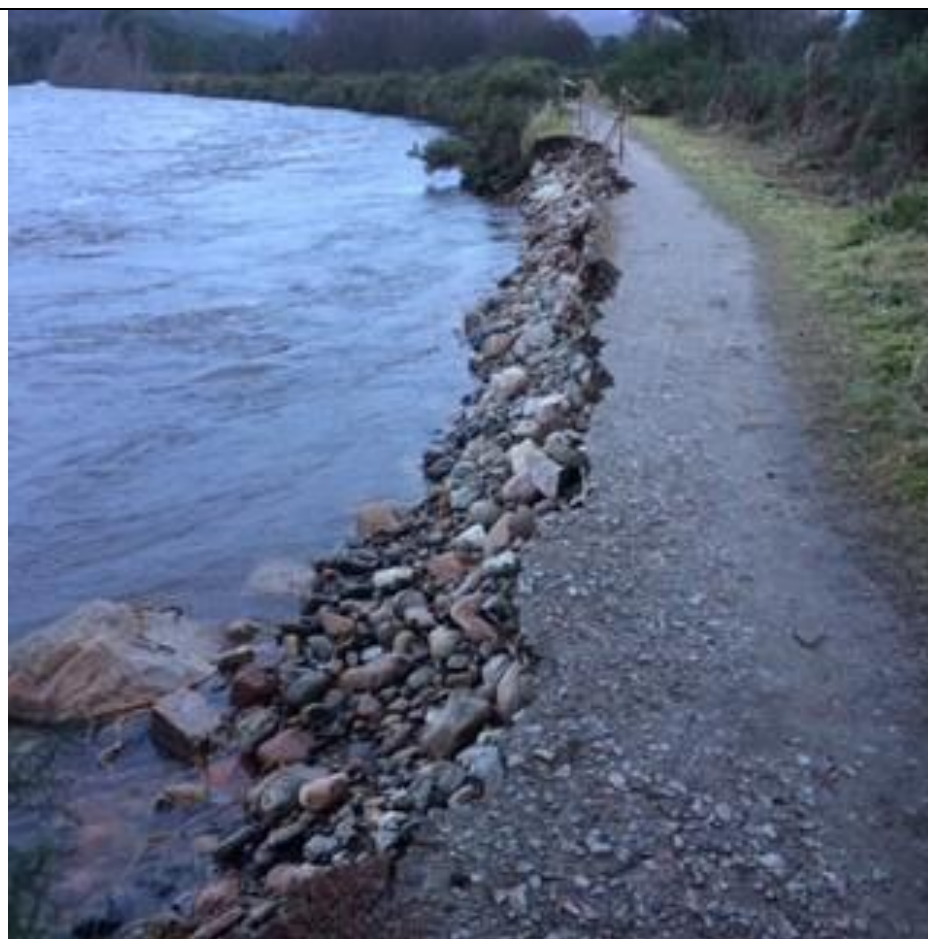
Photo 1: Golf Club Bund on 24th December 2015

- The North bank of the Dee is protected from flooding by a bund initially constructed between 1994 & 1997 with support from the Foundation for Sports and the Arts. The purpose of the bund was to protect the golf course and consequently the village from flooding by overflow either preventing or reducing the flooding.
- The Bund runs from the east end of the golf course for about 1 mile to near the Sluivannachie picnic site car park. The height varies between 1 & 5 metres above ground level.
- Pre-bund, the golf course acted as a Dee overflow, or flood plain, in particular the Brockie's Pond area flooding every few years.

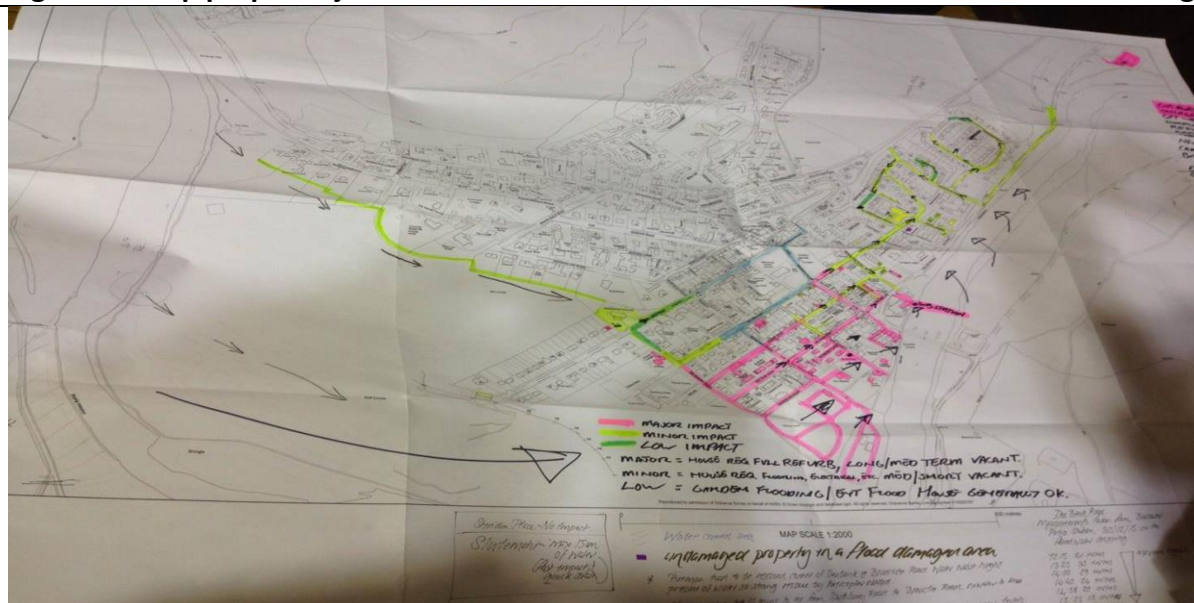
Figure 3: Map prepared just after the flood to show Ballater flow mechanisms & flooding

- SEPA provided a photograph (Figure 3) of a map annotated by AC, showing the reported flow mechanisms & identifying the areas affected by flooding.
- The map shows 3 areas of river flooding upstream of the Bridge:

- Fig 3 also indicates the route of the major flood incursion from the Red Braes, going directly towards the caravan site, which supports the terrible damage inflicted there.

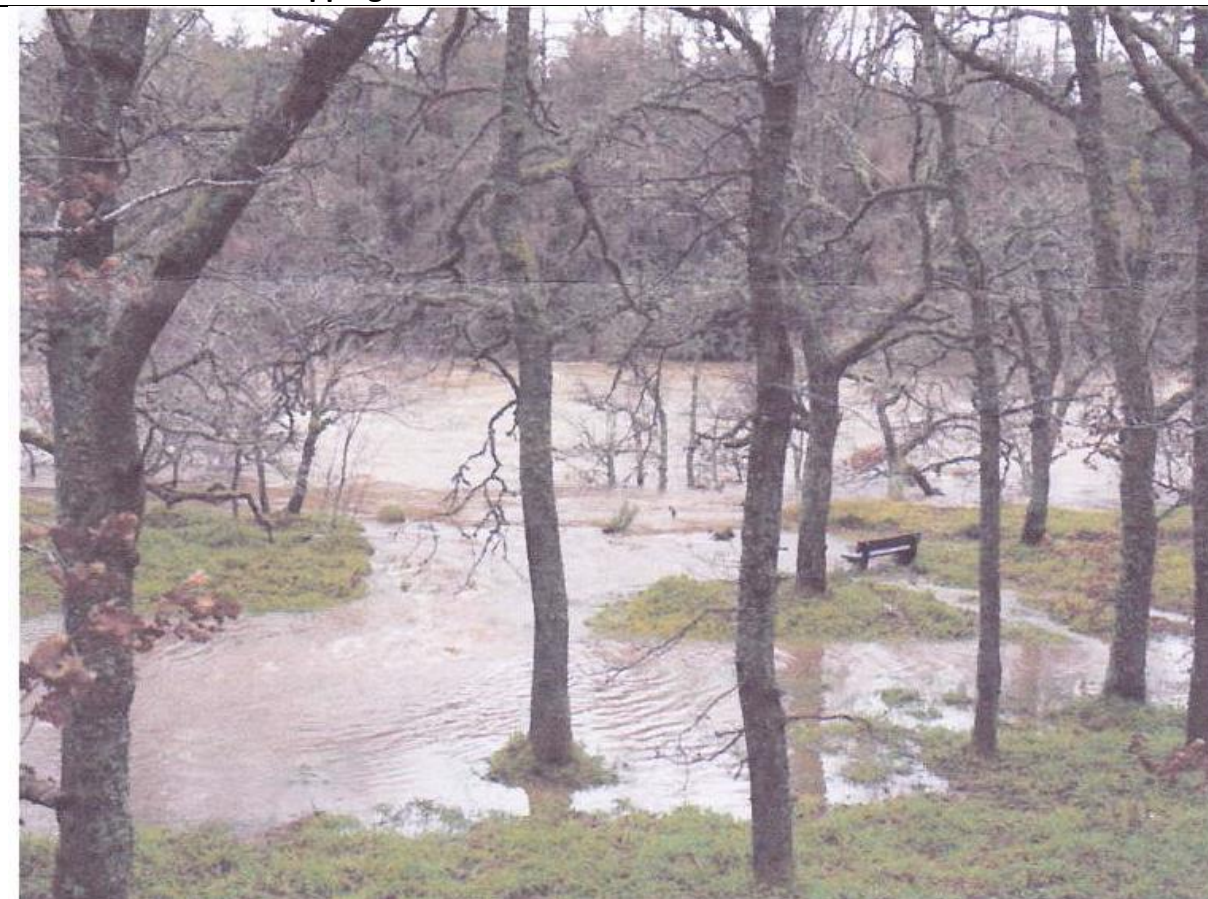
Photo 2: Flood Overtopping at Sluievannichie

- SL is located at the west side of Ballater on the Dee. (see Figure 2)
- SL had flooded in the past (but not recently before 2015).
- In Dec 2015, SL overtopped from about 09.30: the bund remaining intact. (see Photo 2) Water flowed down the yellow route A (Figure 3), coming onto the golf course on 14th Fairway, down 15th fairway (parallel to Abergeldie Rd) & through the Catholic Church grounds and onto Golf Rd. Movement of flood water through the village is dealt with in Section 5.
- SL flooding did not result in deposits of big stones, trees or numerous small stones, indicating the combination of flow rate & water speed was generally not very high, although in places was deeper and caused widespread low level flooding. (Video was taken of SL flood water flows at midday (peak of the flood) confirming this)

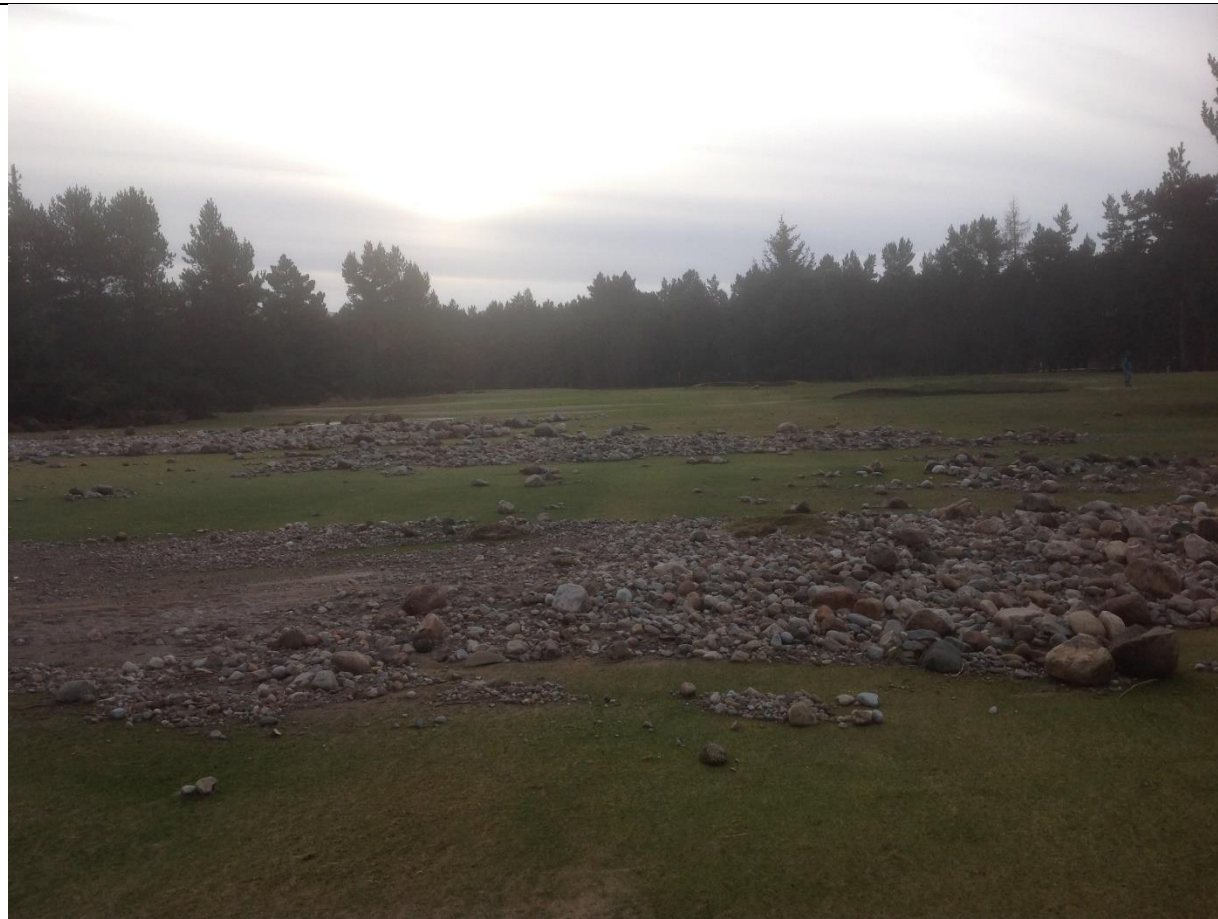
Photo 3: 13th fairway Debris

- In Dec 2015, 13G overtopped, the bund initially remaining intact. The bund at 13G was then breached along a length of c 35 metres - it is suggested this local breach may have happened here due to bund weakness – e.g. animal burrows etc. Water flowed down the middle arrow route on Figure 3: across the 12th, 11th and 10th Fairways ending in Brockie’s Pond – with some flood water also going north to 9th green to join the SL waters.
- 13G flooding resulted in deposits of many big and small stones, indicating the combination of flow rate and water speed was higher – there were no trees indicating trees were not involved in the bund breach. The range of debris may well be from the bund itself, which was formed with river shingle and stones. (course at 13G was photographed after the flood, confirming the type & amount of flood debris & providing reliable evidence of the above)

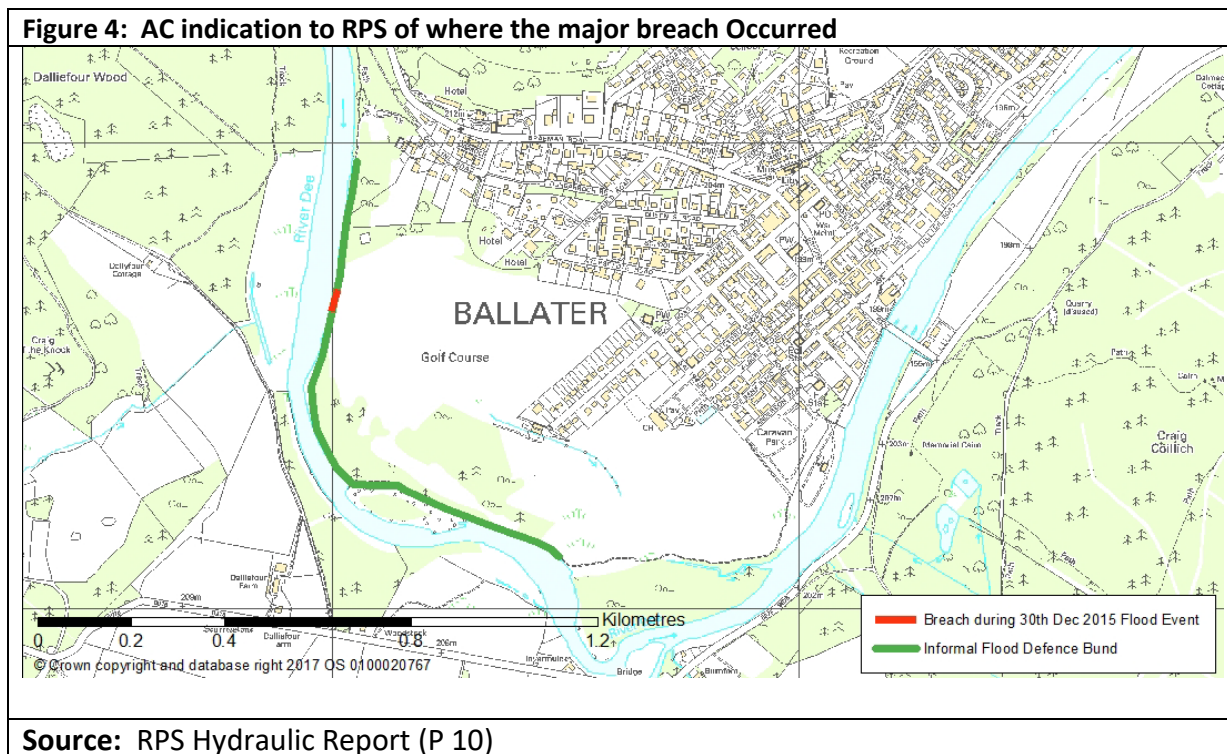
“The location of the breach in the informal flood defence embankment during the December 2015 flood event was identified by AC” & is indicated in Figure 4 below. The breach location in Figure 4 (Red) identified by AC to RPS is not consistent with the major breach in SEPA’s map (Figure 3). Figure 4 shows the breach occurred near 13th Green, which Figure 3 suggests was a lesser breach in comparison to the multiple breaches downstream. (see 4.5)

- RPS were advised by AC as to the location of the major breach.
- Stones and debris had been cleared from the golf course before the RPS walkover on 28th Jun 2017, so RPS observed no physical evidence to confirm the major breach location.

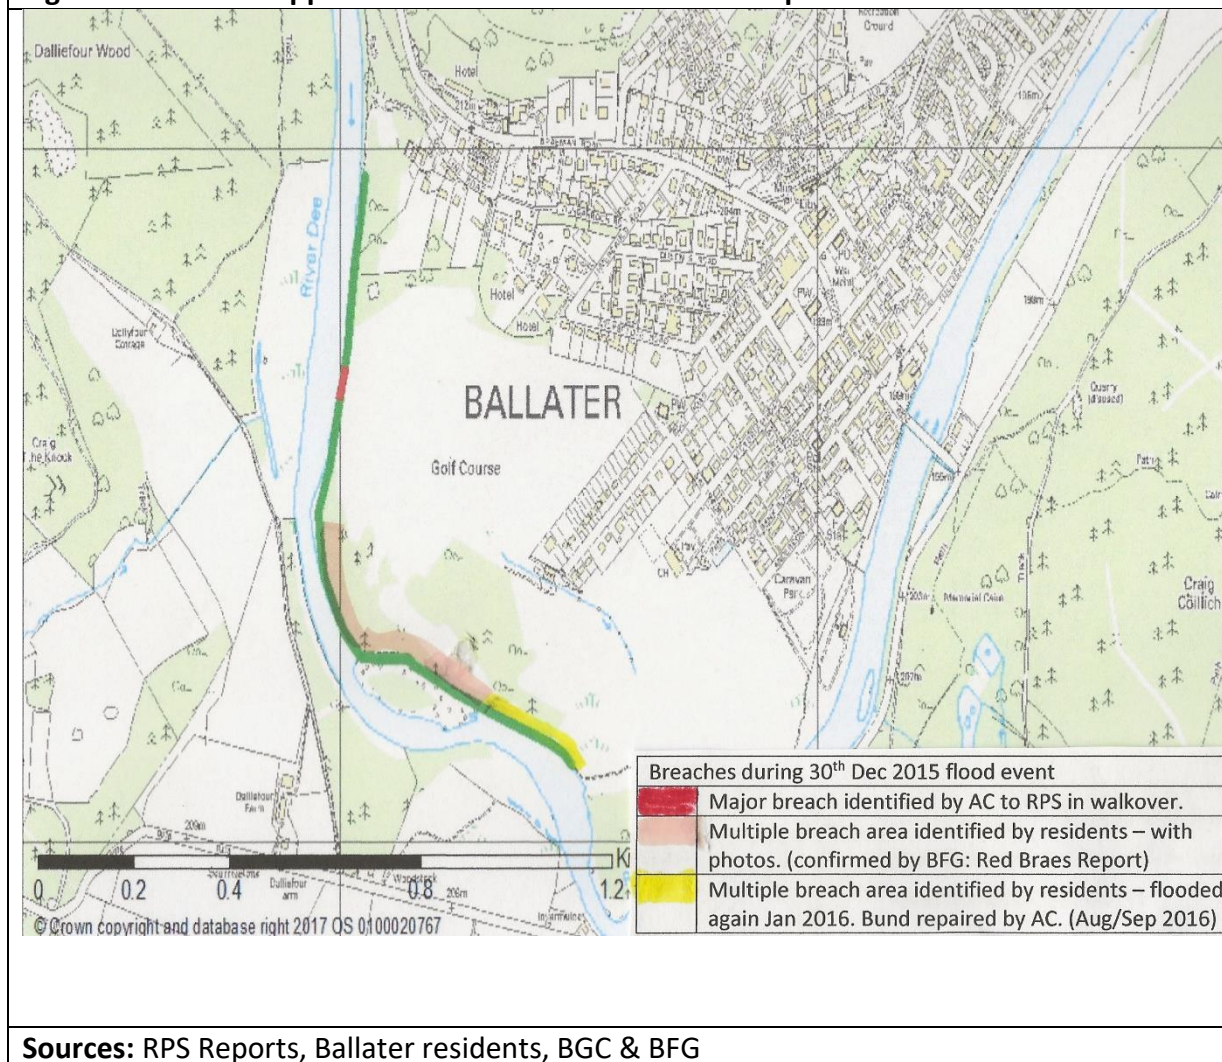
Figure 5: Breaches opposite & downstream of Red Braes: plus 13th Green

- That there was a breach in the area of 13th green, & its scale 35m wide, is agreed by AC, RPS, BFG and others who have studied the flood or observed the resulting damage. All parties also agree this breach was not caused by the collapse of the Red Braes. (Figs. 4 & 5: Red)

- In January 2016, there was a small flood affecting only BGC which resulted from the breached bund in the area marked yellow. (Figure 5) In Aug/Sep 2016, AC took the initiative & repaired a length of about 40metres in the yellow area, to reduce the risk of flooding in this area. The repair was with rock armour and to a height of 1-2 metres.

- The short width of the breach at 13th Green suggests this was not the major breach and the narrow width would not support the rapid increase in flow rate & flood depth.

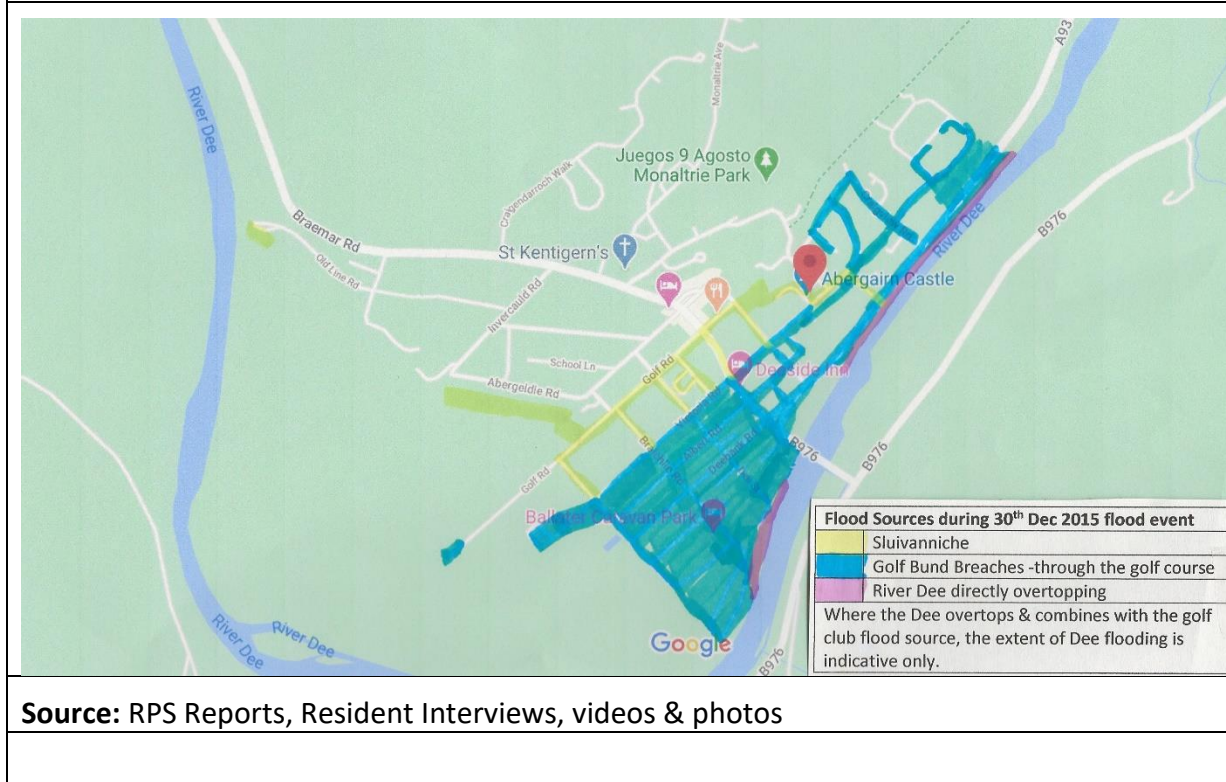
Figure 7: Areas Flooded by Source of Flood Water

- The Sluievannichie flood source was an overtopping with flood water usually no more than 30cms as it approached the village at Golf Rd. However, this caused large areas of the village to flood (see Figures 6 and 7). The flooded areas were so large as (1) a steady supply of flood water was channelled into the village, (2) the point of supply of this water was at the upper end of the village and the water had to drain through the village to the Dee & (3) as the upper end of the village is flat, the flood waters were able to travel a long way east (across Bridge St) & damage considerable areas in the east of the village.

- 13th Green & Red Braes flood waters joined as they came across the golf course.
 - **North area of BGC:** Although the flood water height was only 30cms, there was a powerful supply of water & nothing to stop this. Consequently, the flood water damaged most of the lower village between Salisbury Rd & Bridge St. These flood waters crossed Bridge St & did extensive damage in the East of the village, where in some areas flood water could not escape & depths increased to greater levels.

- **South area of BGC:** This is lower lying, resulting in deeper water, 1metre, and much faster flows, with real and significant danger to life. The southern area consequently suffered the most extensive damage, including destroying all 100 fixed mobile homes at the caravan site and washing large objects & debris through the village damaging walls, property etc. These flood waters crossed Bridge St & did extensive damage in the East of the village.

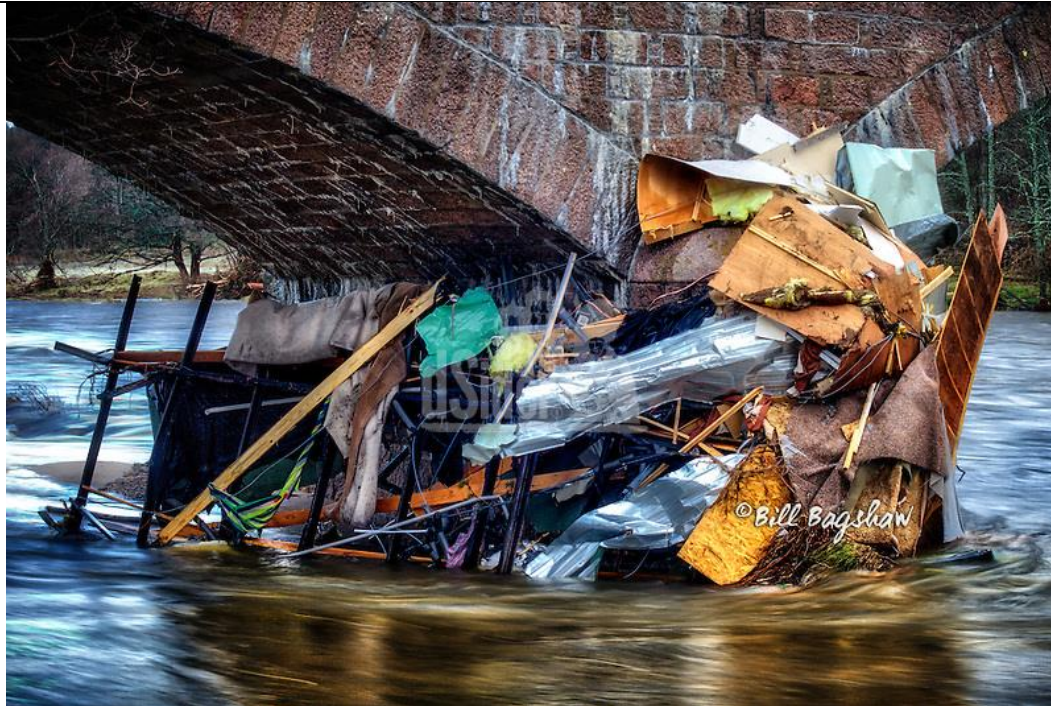
Photo 9: The Bridge after the Flood showing debris – which would restrict flow

- In addition to The Bridge being at risk through high river levels, it was also seriously damaged by scouring. As flow increased through The Bridge, debris scoured the river bed undermining The Bridge's foundations.

- **There is also a risk that as a result of these factors, The Bridge will cause an obstruction to the river flow and contribute to flooding the village.**

- AC has repaired The Bridge more than once. The repairs strengthened The Bridge structure.
