Ballater & Crathie Community Council (BCCC)

December 2015 Ballater Flood

Flood Information Group
December 2015 Ballater Flood
Report 1 Causes, Mechanism & Uncertainties

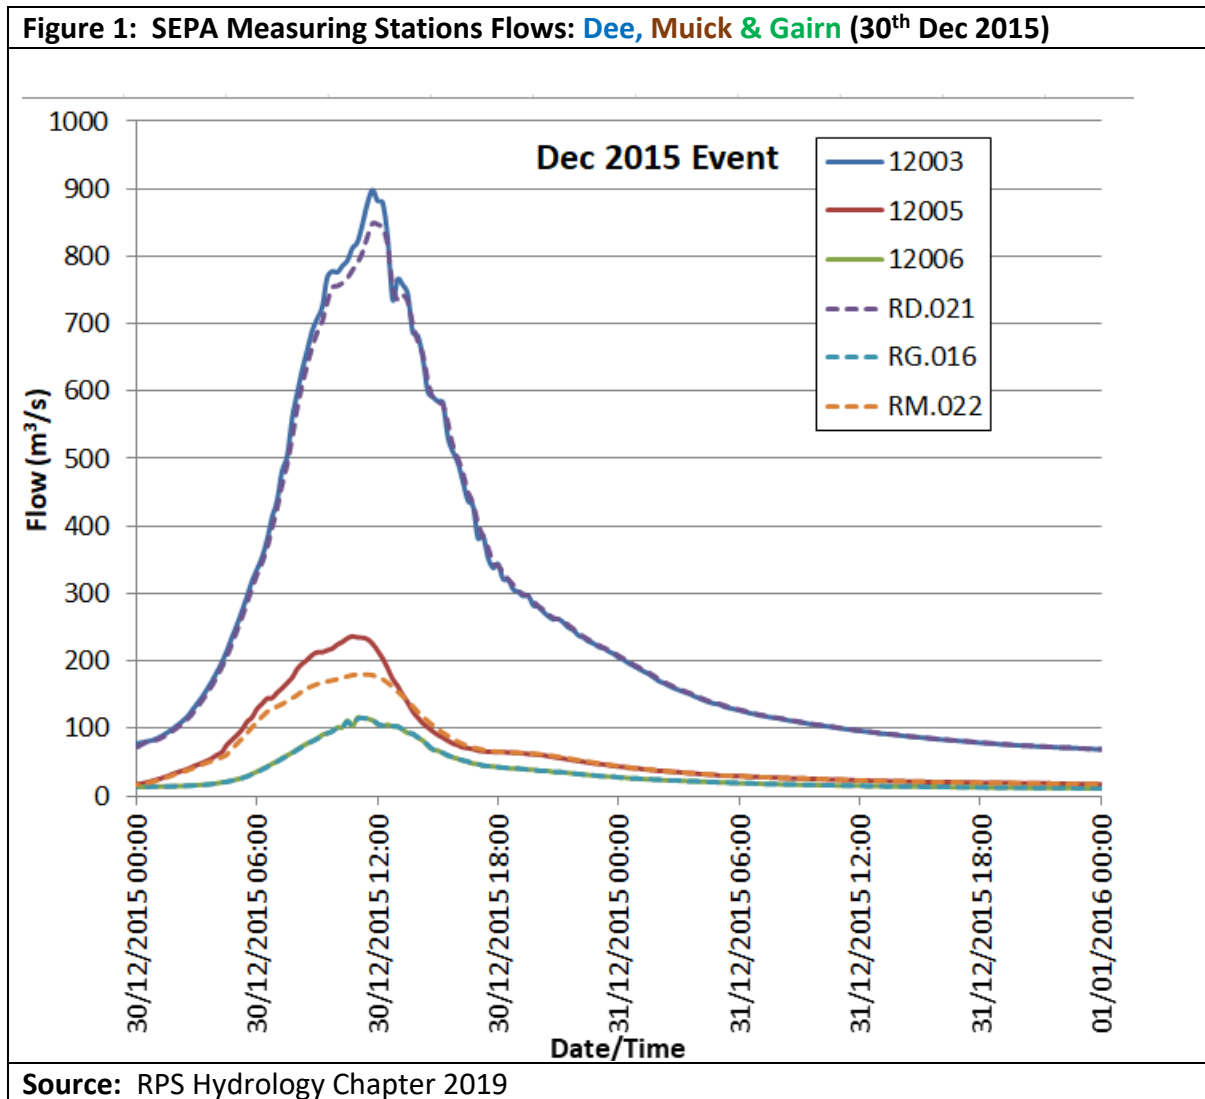
- Water volumes on the 3 rivers upstream of Ballater are shown in Figure 1 – prepared by RPS. (SEPA stations Polhollick, Muick & Gairn).
- It is clear the flood had a sharp peak lasting a few hours – during which Ballater flooded.
- Previous floods have the same peaking pattern – though with a much lower peak.

- At 08.00, 30th Dec 15, Ballater had flows exceeding anything previously recorded: >770 cuM/sec
- For the next 8 hours (08.00-16.00), Ballater had flows >770cuM/sec
- For 4 hours of the peak (10.00-14.00), flow was >1000cuM/sec.
- At the peak (about 12.00), the maximum flow rate was around 1250cuM/sec.
- Ballater suffered a sharp, extreme and violent event.
- To get a clear sense of the situation at the flood peak, it is important to get evidence (photographs, videos, witness statements, etc). RPS Reports contained no photographs

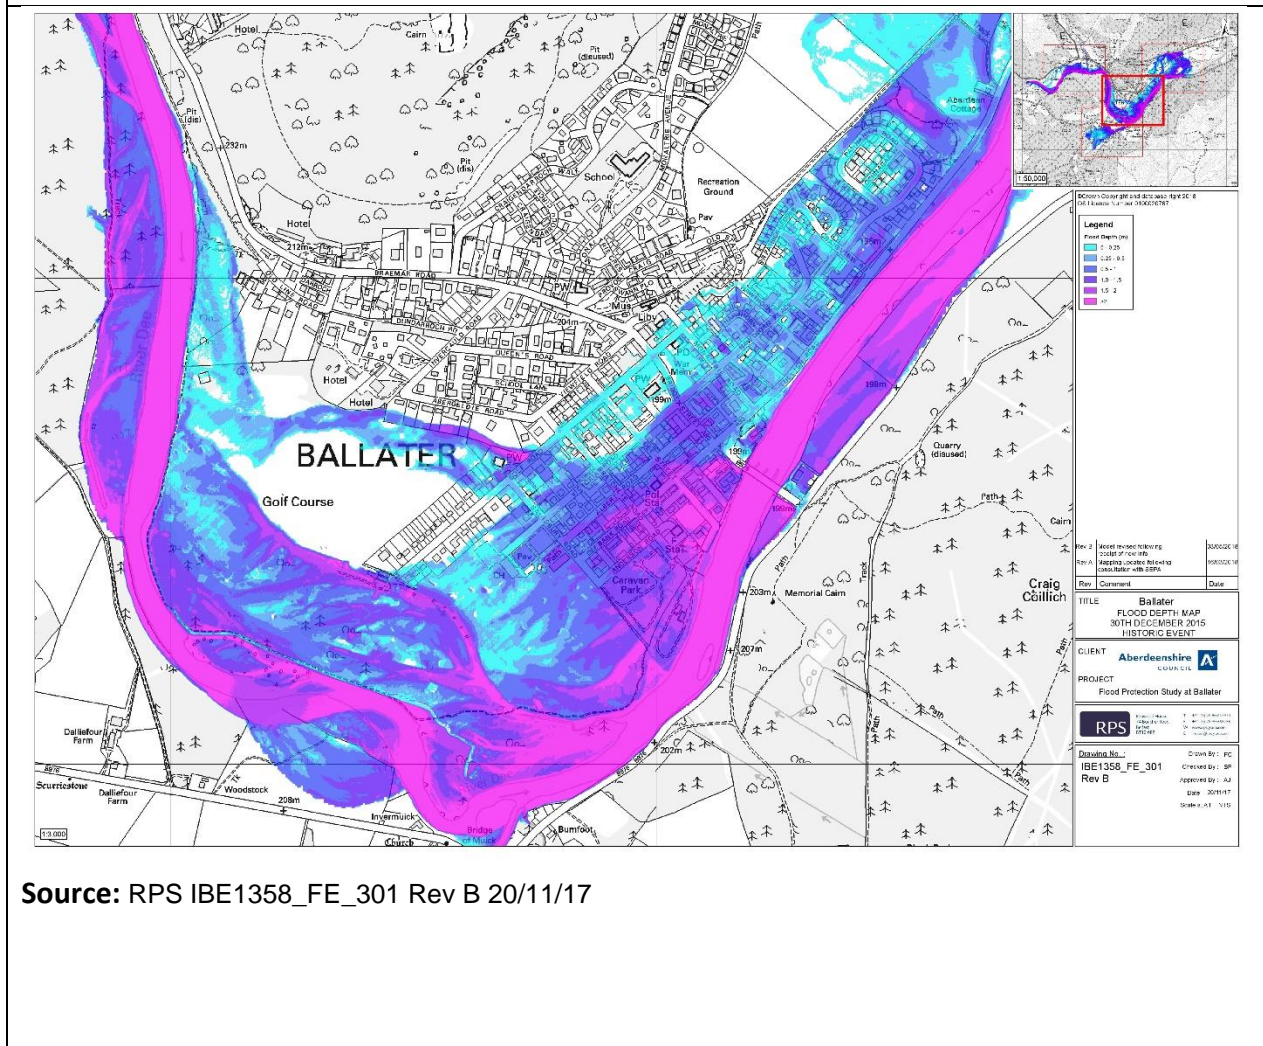
Figure 6: Flood Depth Map 30 December 2015 Historic Event

- In the caravan park & Dee St area, flood water levels exceeded 2metres. Flood water arrived both from the Dee overtopping at Dee St & the BGC, but the force and direction of the flow was from BGC. This flood water was at a similar level to the river water, the body of water becoming one whole. Therefore, the river appears to have overtopped by more than 2 metres in places. (See Figure 6)

- The Sluievannichie flood source was an overtopping with flood water usually no more than 30cms as it approached the village at Golf Rd. However, this caused large areas of the village to flood (see Figures 6 and 7). The flooded areas were so large as (1) a steady supply of flood water was channelled into the village, (2) the point of supply of this water was at the upper end of the village and the water had to drain through the village to the Dee & (3) as the upper end of the village is flat, the flood waters were able to travel a long way east (across Bridge St) & damage considerable areas in the east of the village.

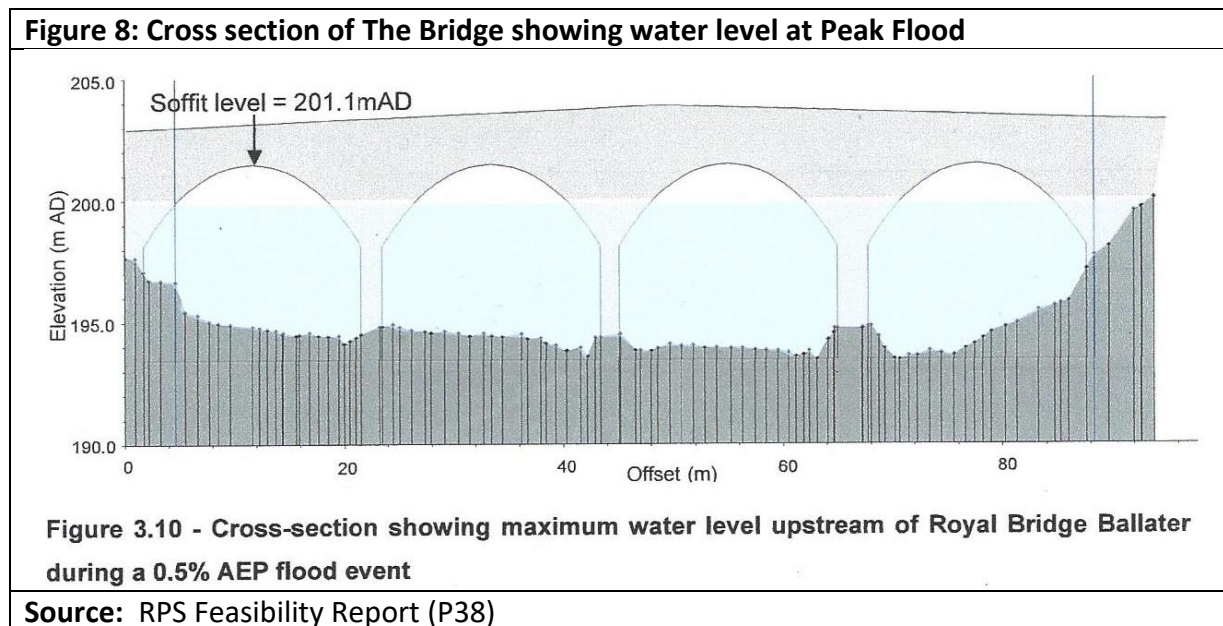
2. **If one of the 4 arches of The Bridge were fully blocked it would have no material effect on upstream water levels.** RPS conclusion from the model: “The largest impact on water levels is seen at the upstream face of the bridge where the water depth increases by 81mm. It made no significant difference to the river levels or flood extents, and had no impact on the number of properties affected. Therefore, the model can be considered to have a low sensitivity to blockage at the Bridge, with a low impact on the number of properties affected.” (HAC: P50)

3. **If The Bridge was removed the upstream water level effect would be small** - RPS concluded: “water levels were found to be 340mm lower in the bridge-out scenario.”

However, RPS expressed caution about their conclusions regarding The Bridge, suggesting if flood defences were to be built, bridge modelling should be redone to confirm that the structural integrity of the bridge was not at risk. “should an option which incorporates direct defences be implemented, it is recommended that additional investigation into the potential for scour is undertaken to ensure that the flood alleviation scheme does not compromise the integrity of the bridge.”

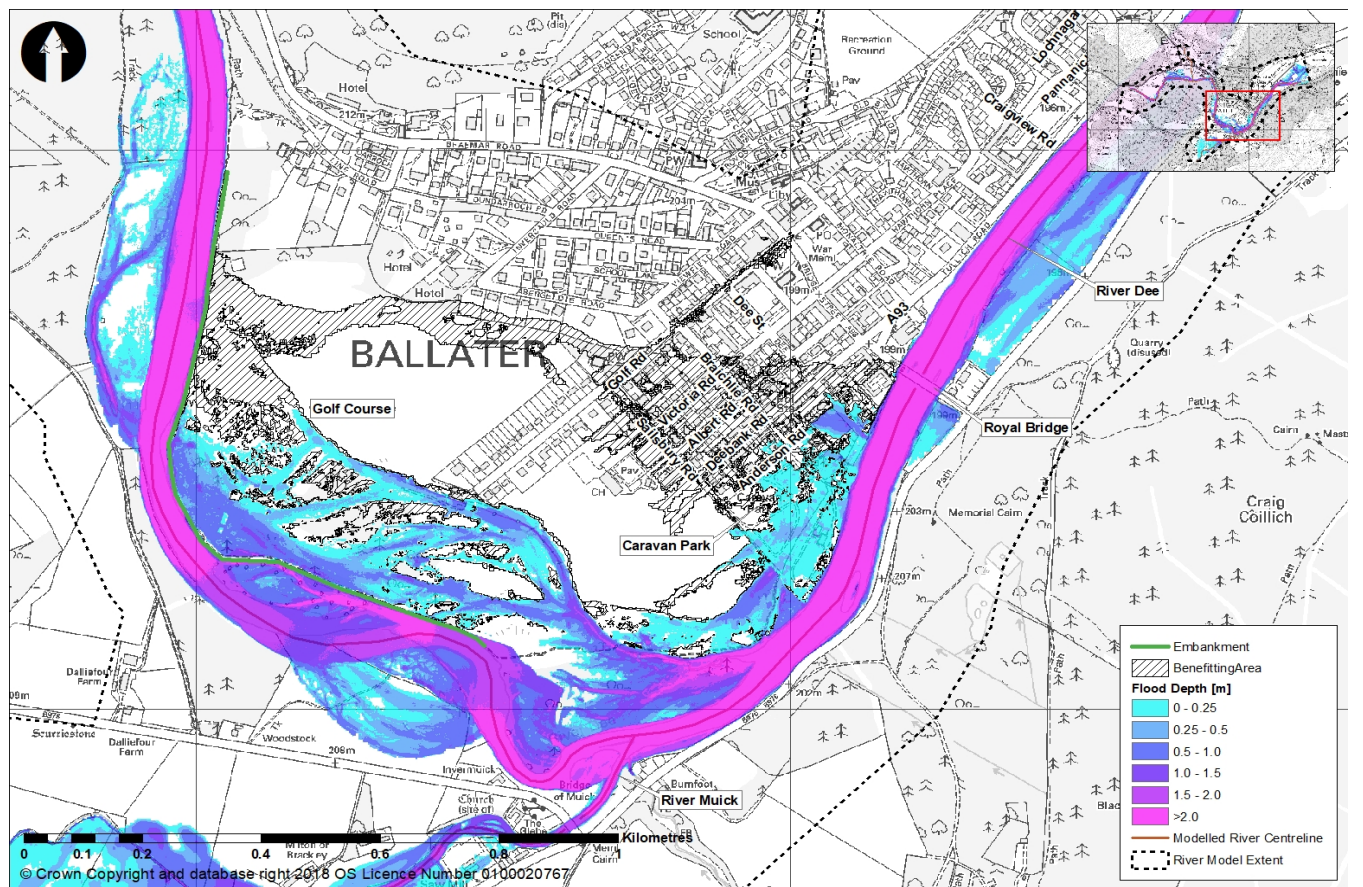
Figure 9: Flood Map, showing areas of Ballater and the lower Muick benefiting from the Bund during a one in five year event

This SEPA map (Figure 9) shows the following

1. the southern parts of Ballater and parts of the lower Muick would flood.
2. Flooding depth would typically be less than 25cms.
3. Golf Rd and northern parts of Ballater would be protected by the bund

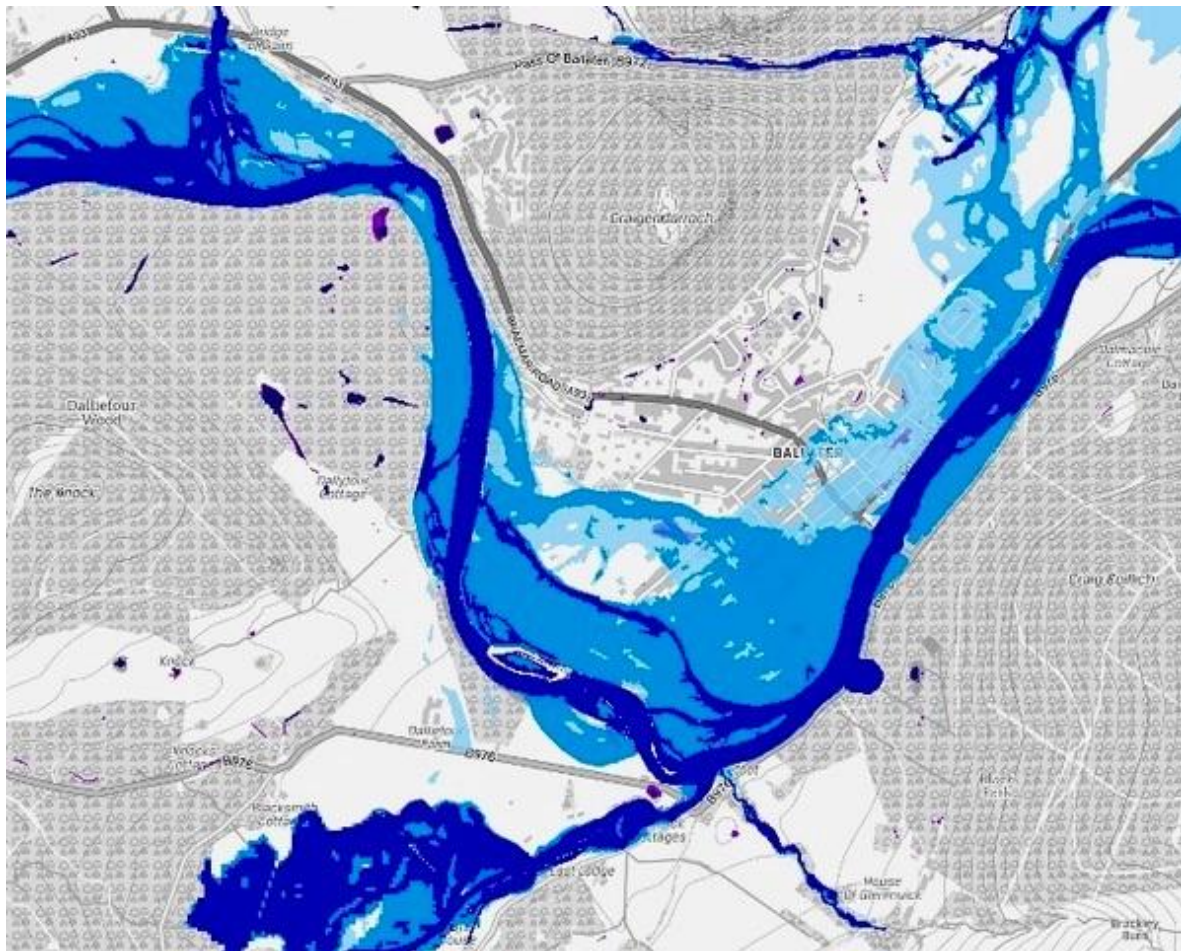
Figure 10: SEPA Flood Map accessed November 2020, showing areas of Ballater and the lower Muick at high, medium and low risk of flooding

This SEPA map (Figure 10) shows the following:

- (1) prevent the catastrophic & life threatening events of 2015 &
- (2) further mitigate the damaging effects of lower level but more frequent flooding in the area.
